Debris/Ice/TPS Assessment And Integrated Photographic Analysis For Shuttle Mission STS-49

July 1992

Gregory N. Katnik
NASA/Kennedy Space Center

OV-105 Endeavour (1st flight), ET-43 (LWT 36), BI-050 SRBs

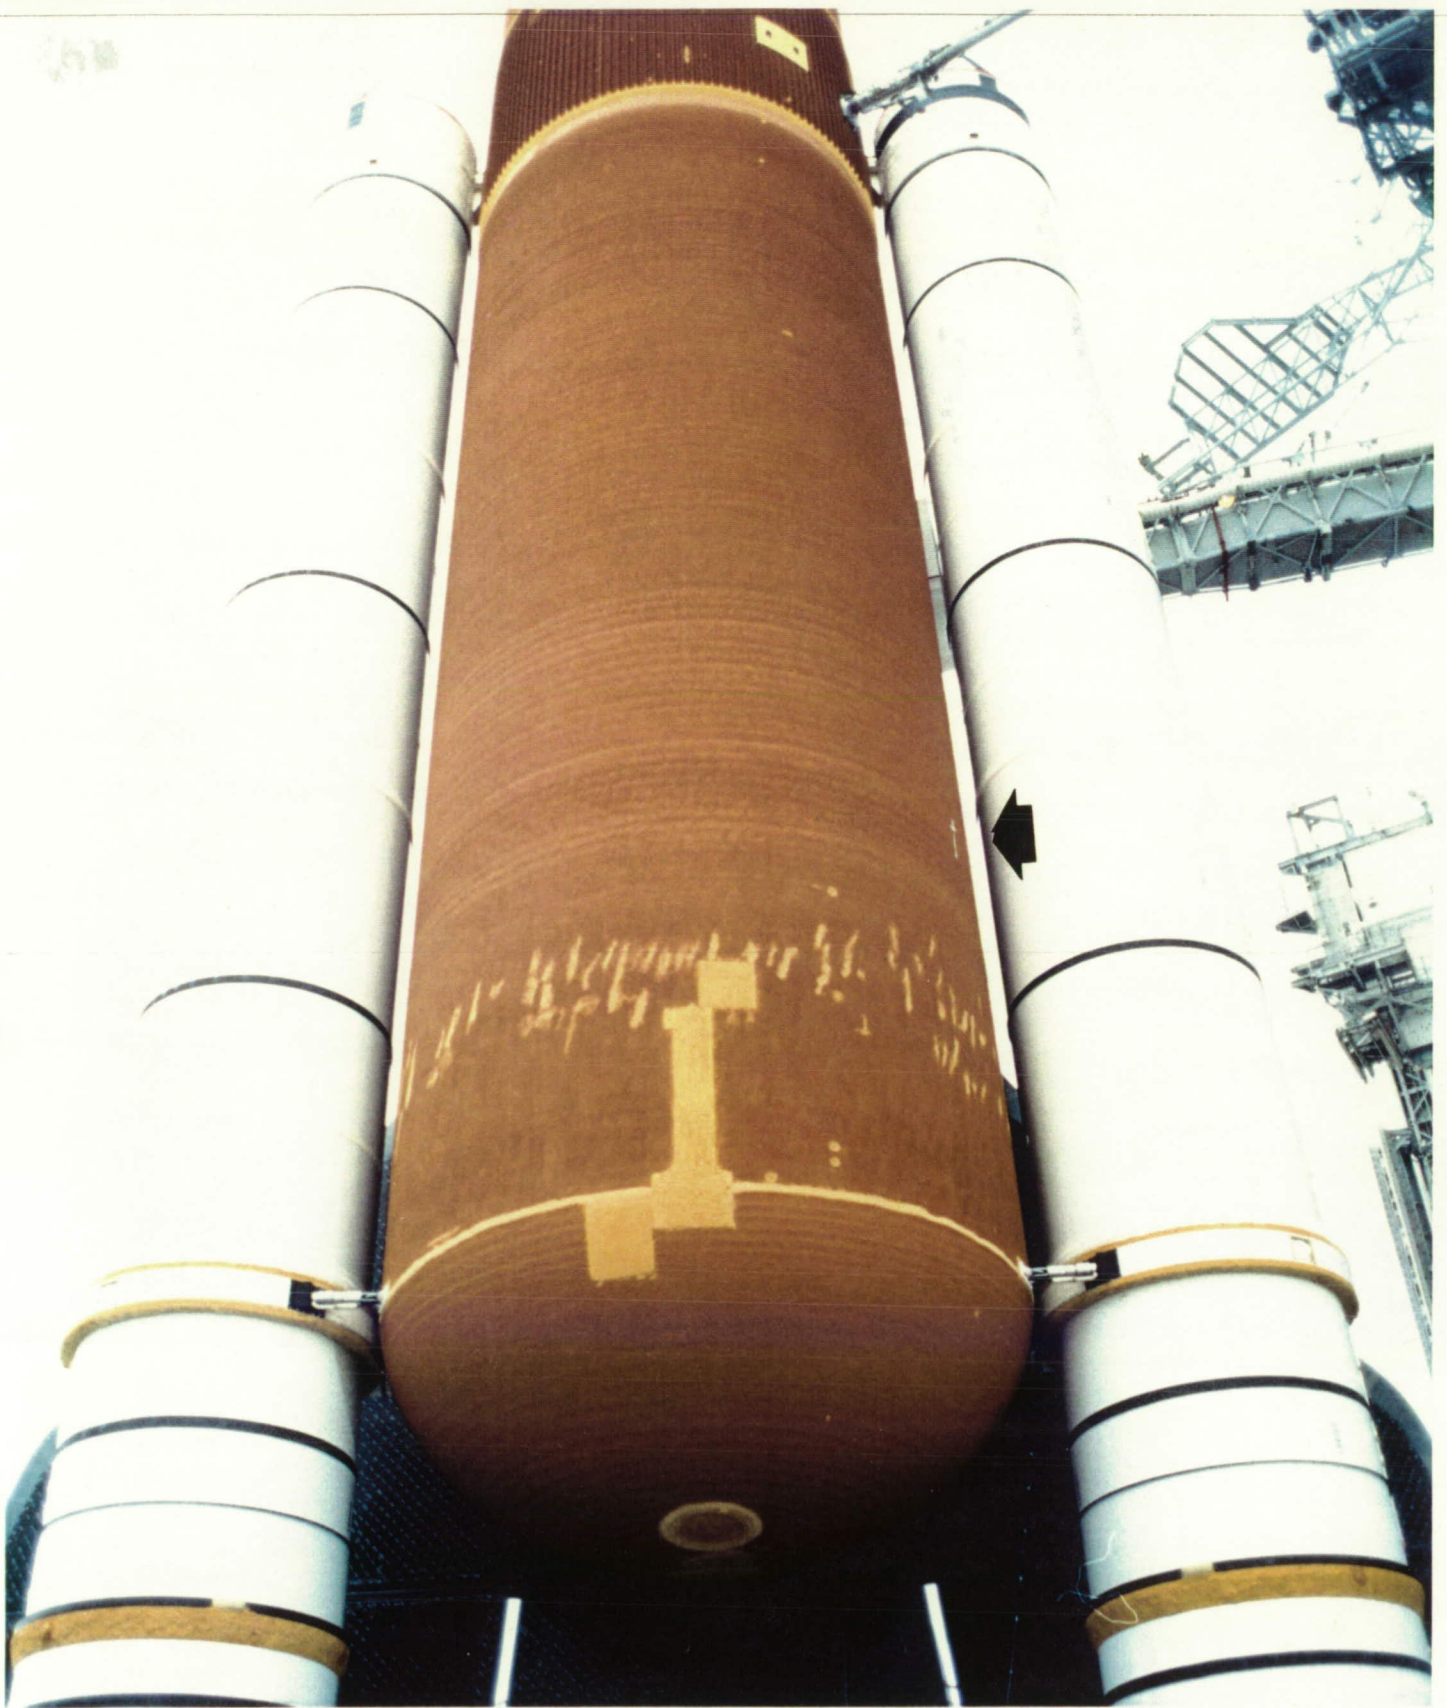
Prior to the Flight Readiness Firing, a piece of rope was observed adhering to the LH2 tank TPS below the GUCP and approximately 85 feet above the MLP deck. Since the rope was on the -Z side and not a debris concern, and would not affect TPS performance, it was not removed prior to launch.

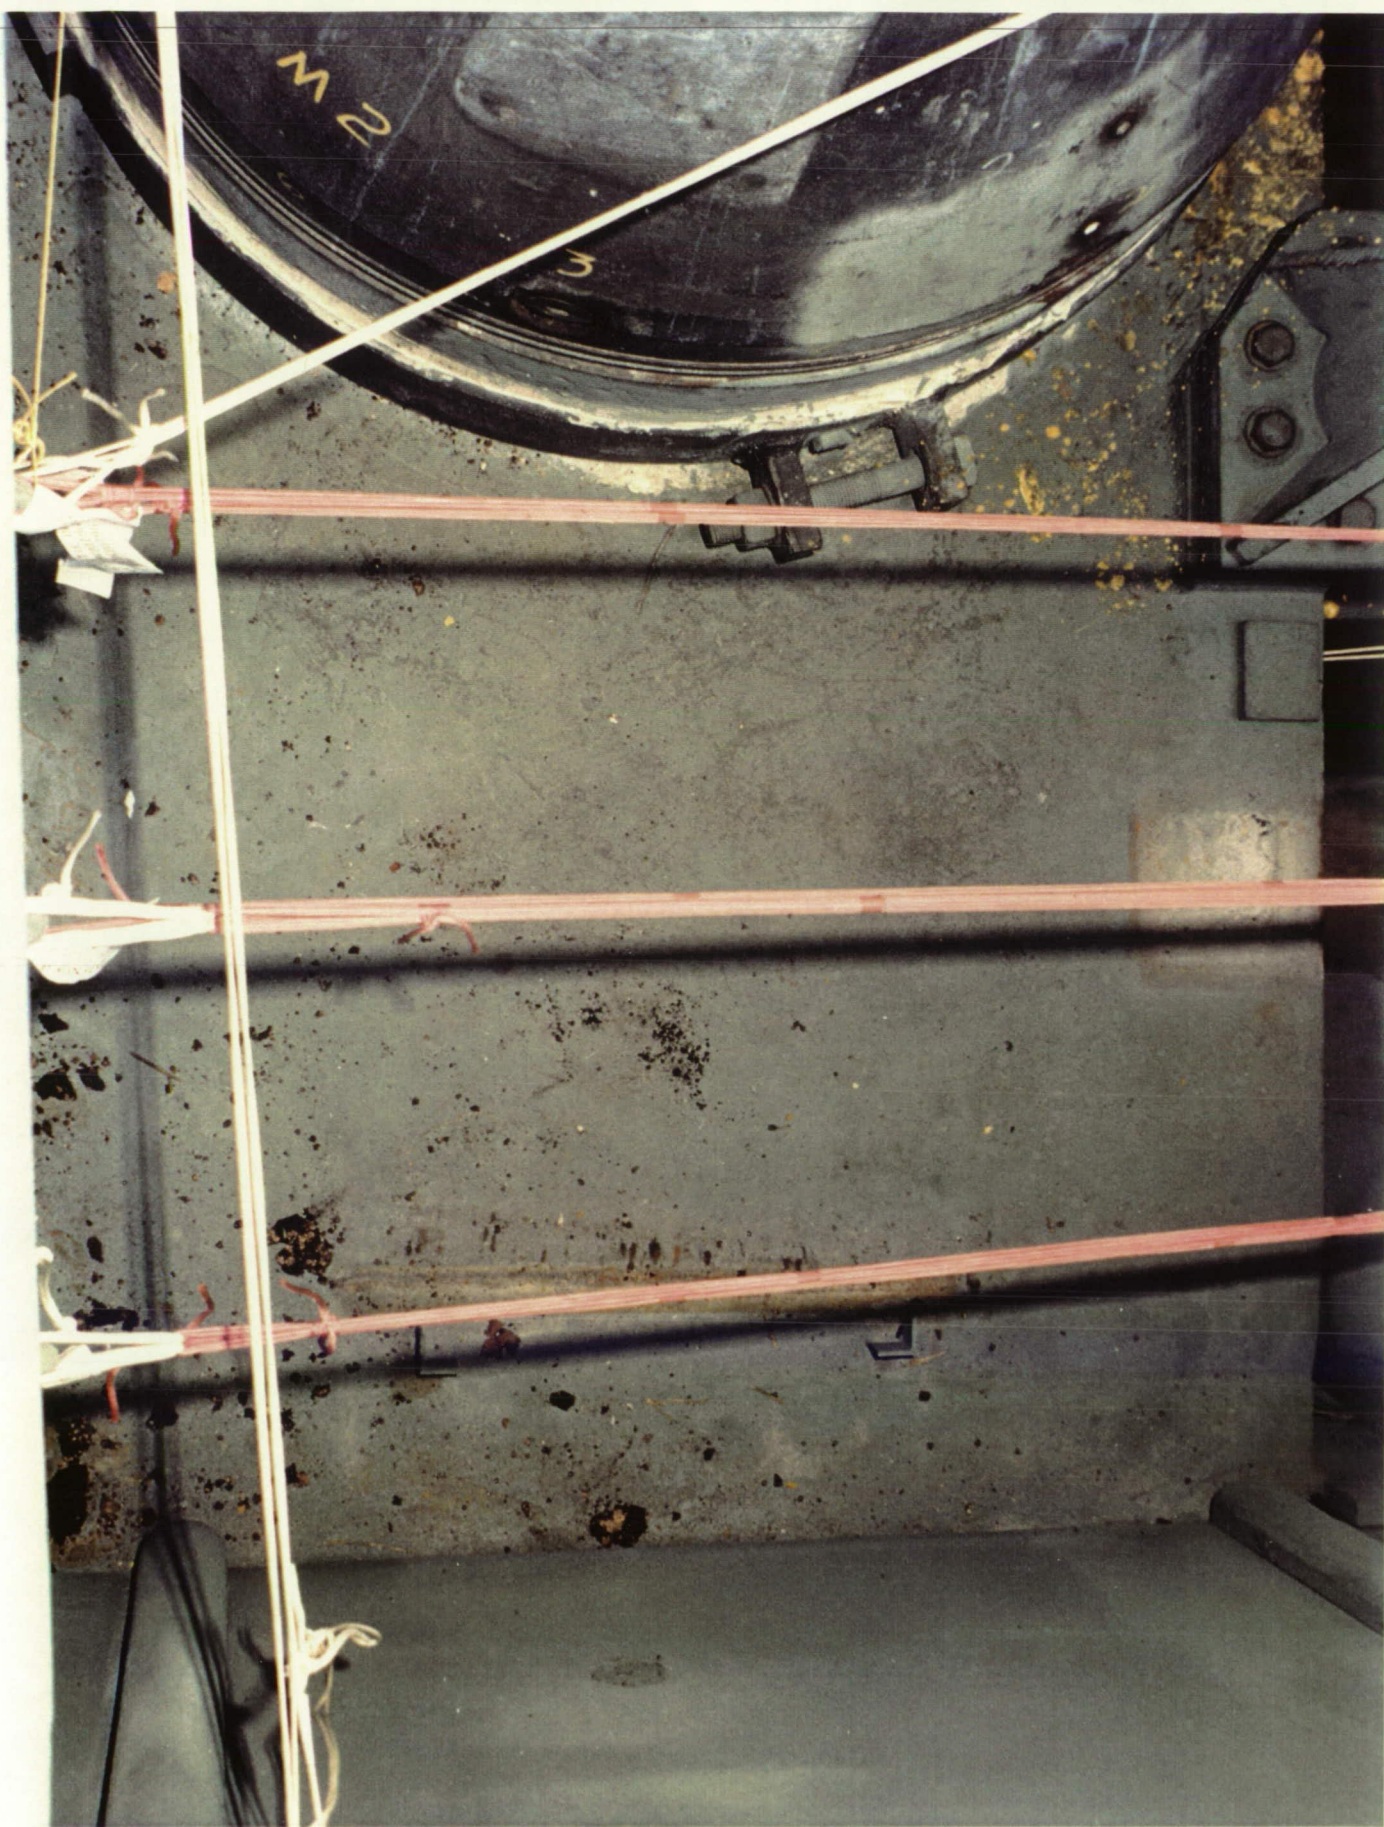
Loose debris, rust, MLP deck scale, and foam trimming in the SRB holddown post haunch areas were removed prior to launch.

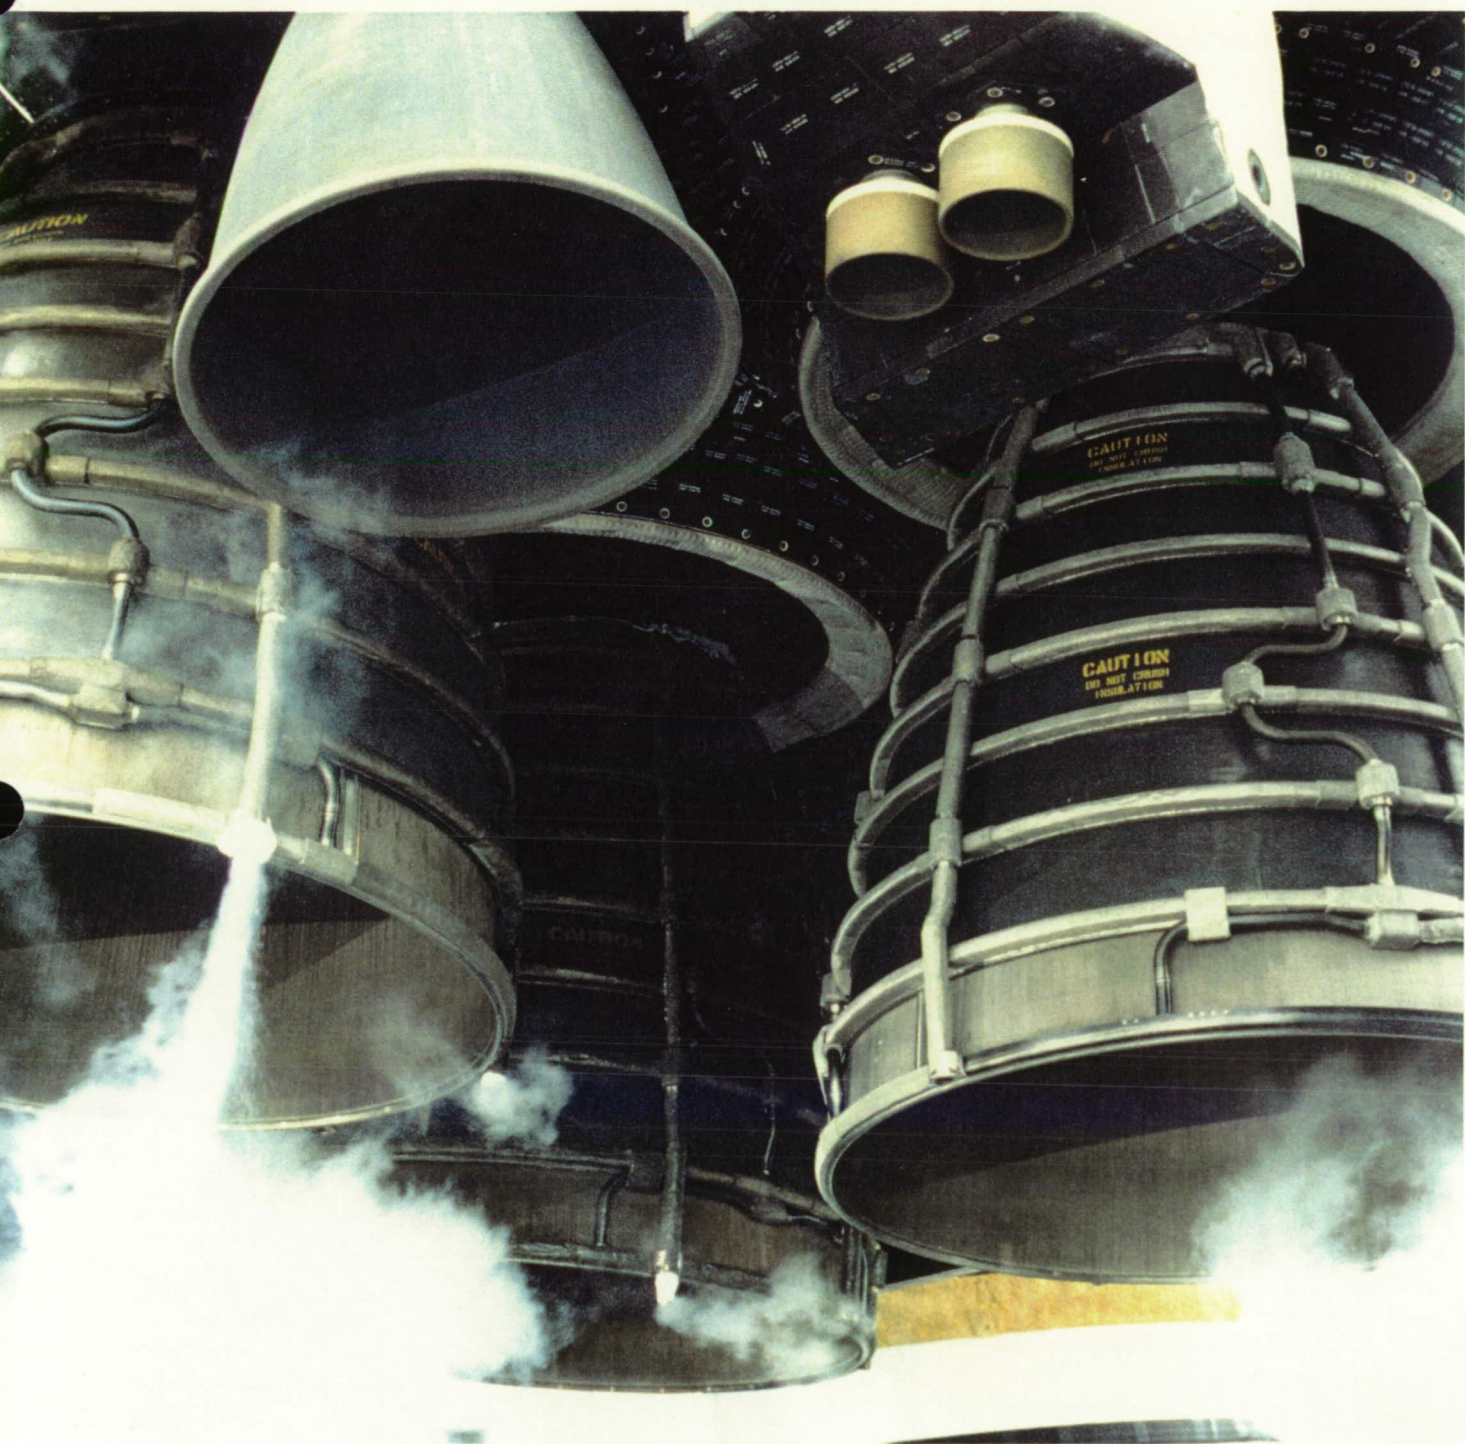
Overall view of the SSME's. Ice/frost had accumulated on the SSME #1 and #2 heatshield-to-nozzle interfaces. An infrared scan revealed no unusual temperature gradients on the base heat shield or engine mounted heat shields.

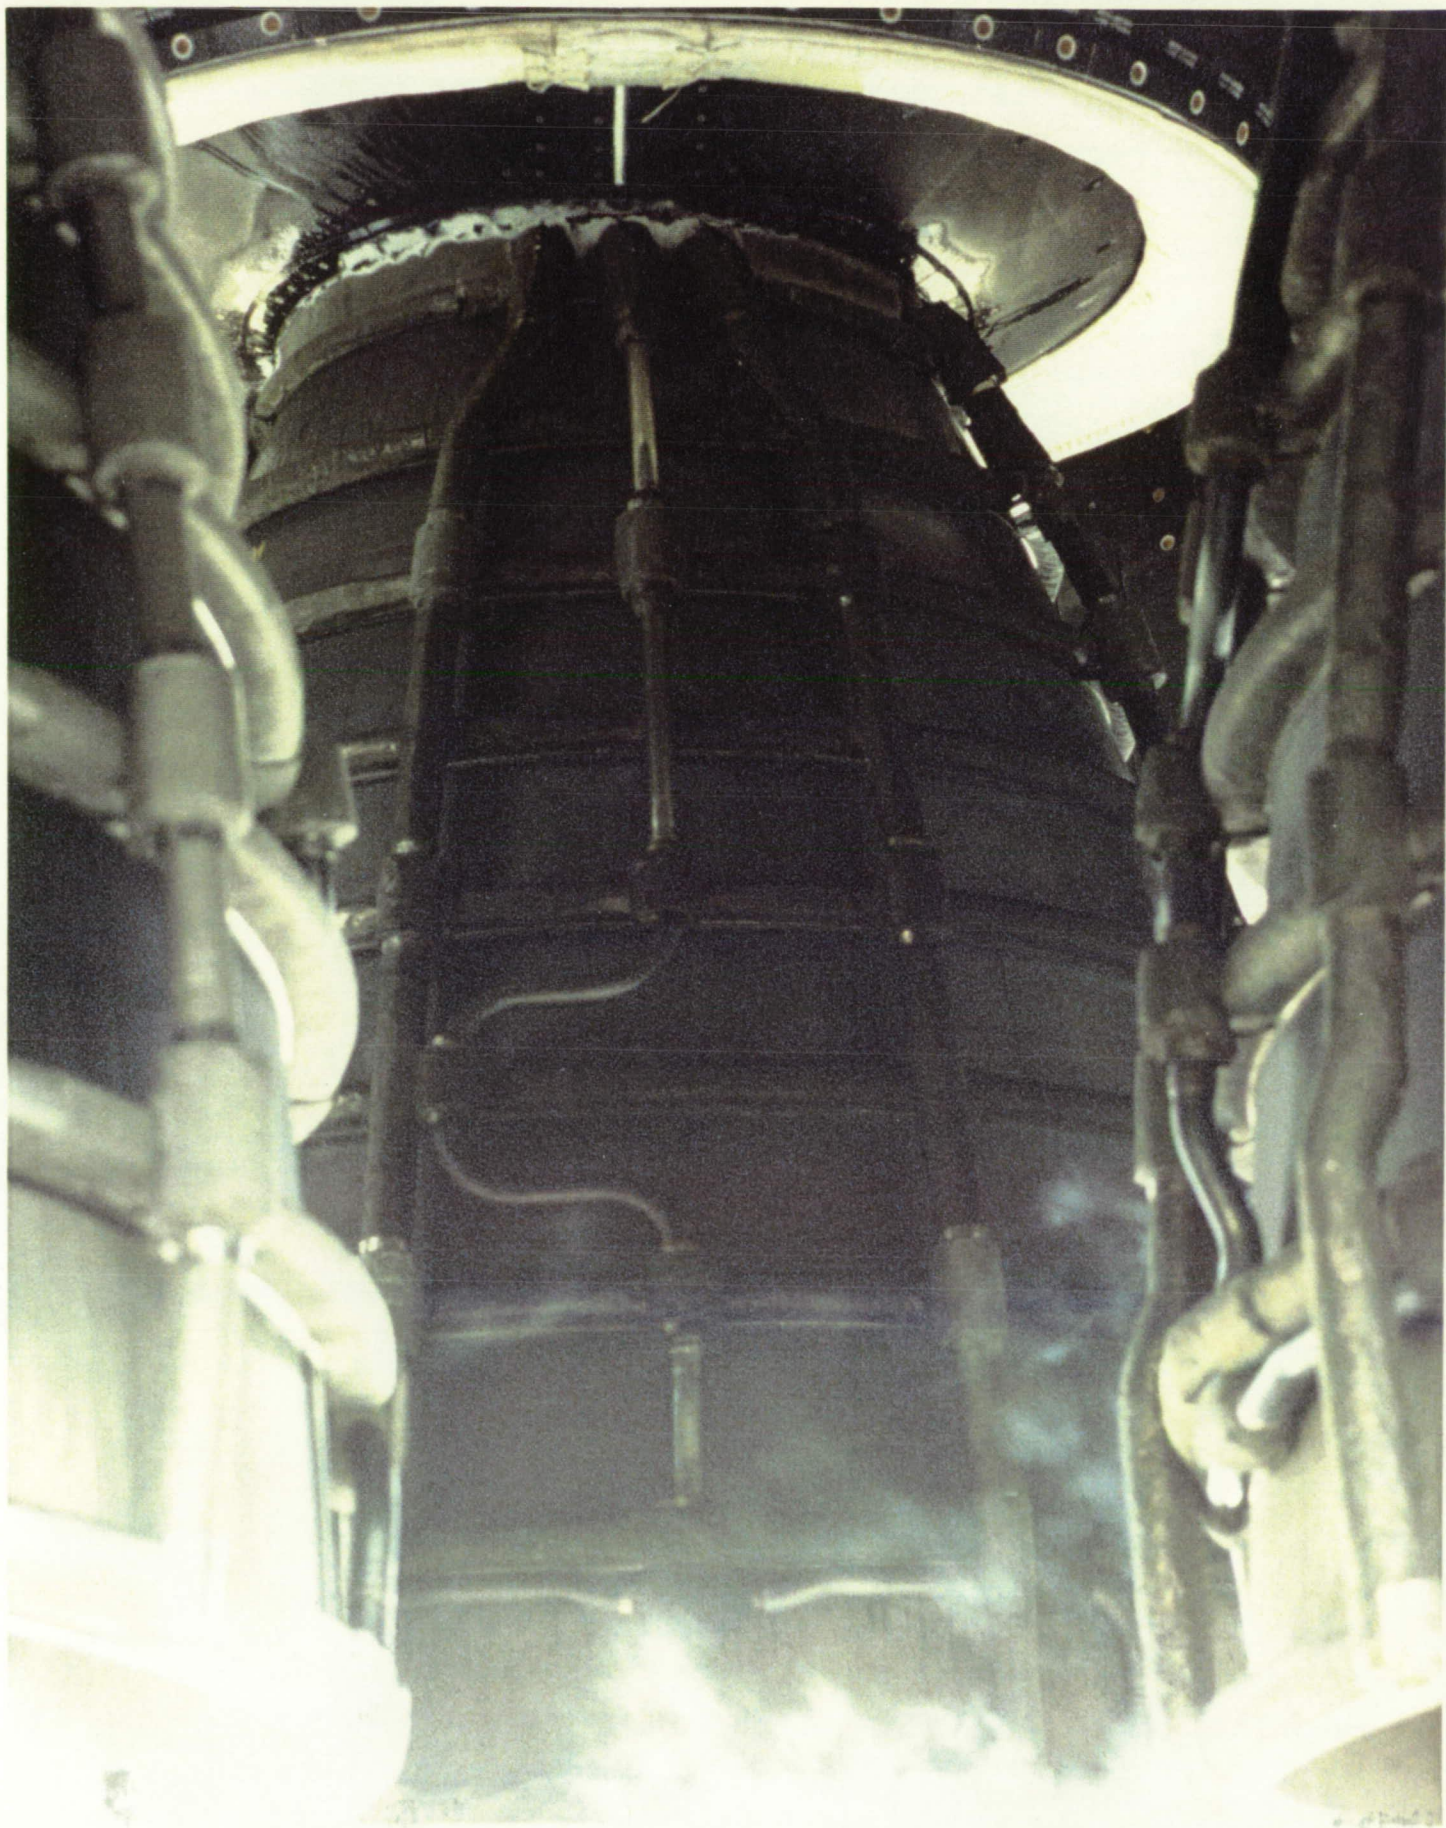
Ice/frost and condensate were present on the SSME #1 heat shield-to-nozzle interface.

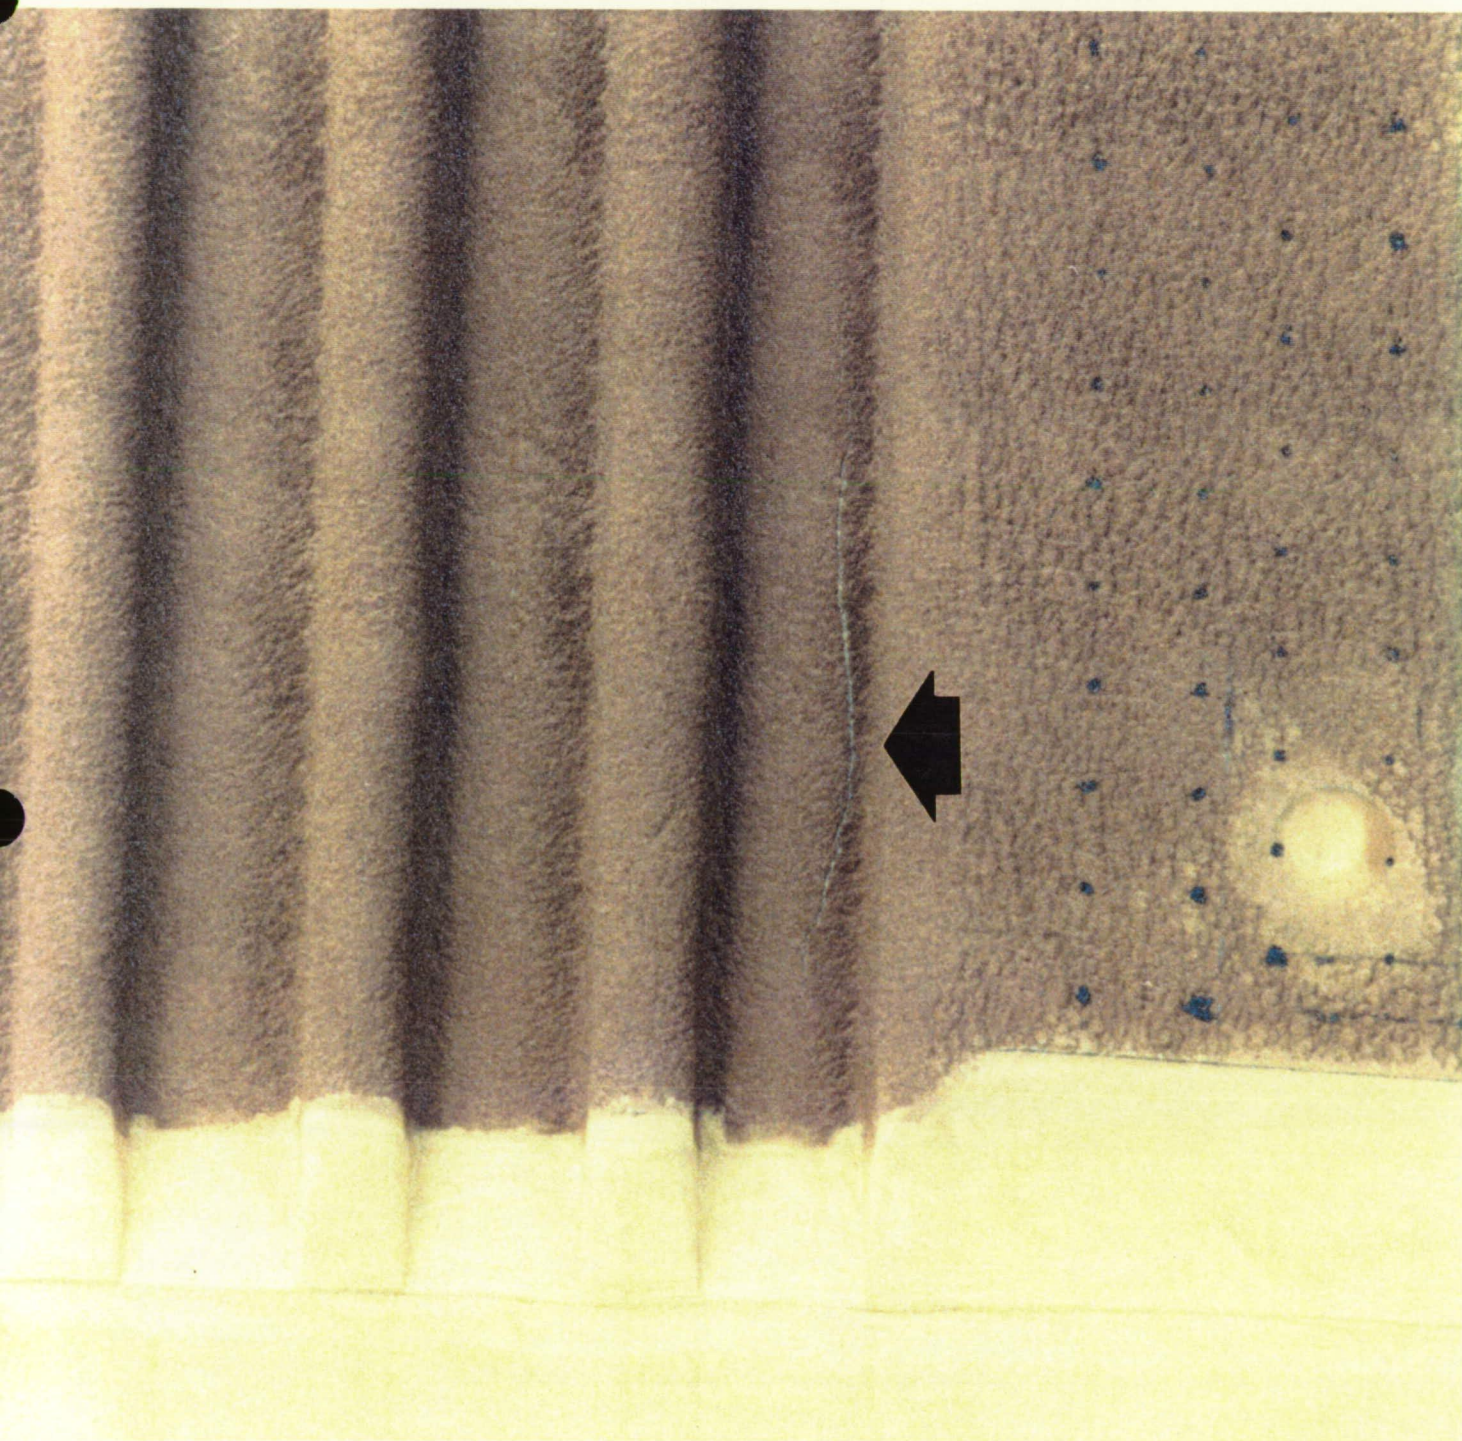
The thermal stress crack in the intertank TPS stringer valley adjacent to the -Y thrust panel reappeared during cryogenic loading. Characteristics of the crack (18-20 inches long, 1/4-inch wide with no offset, and not filled with ice or frost) had not changed since FRF.

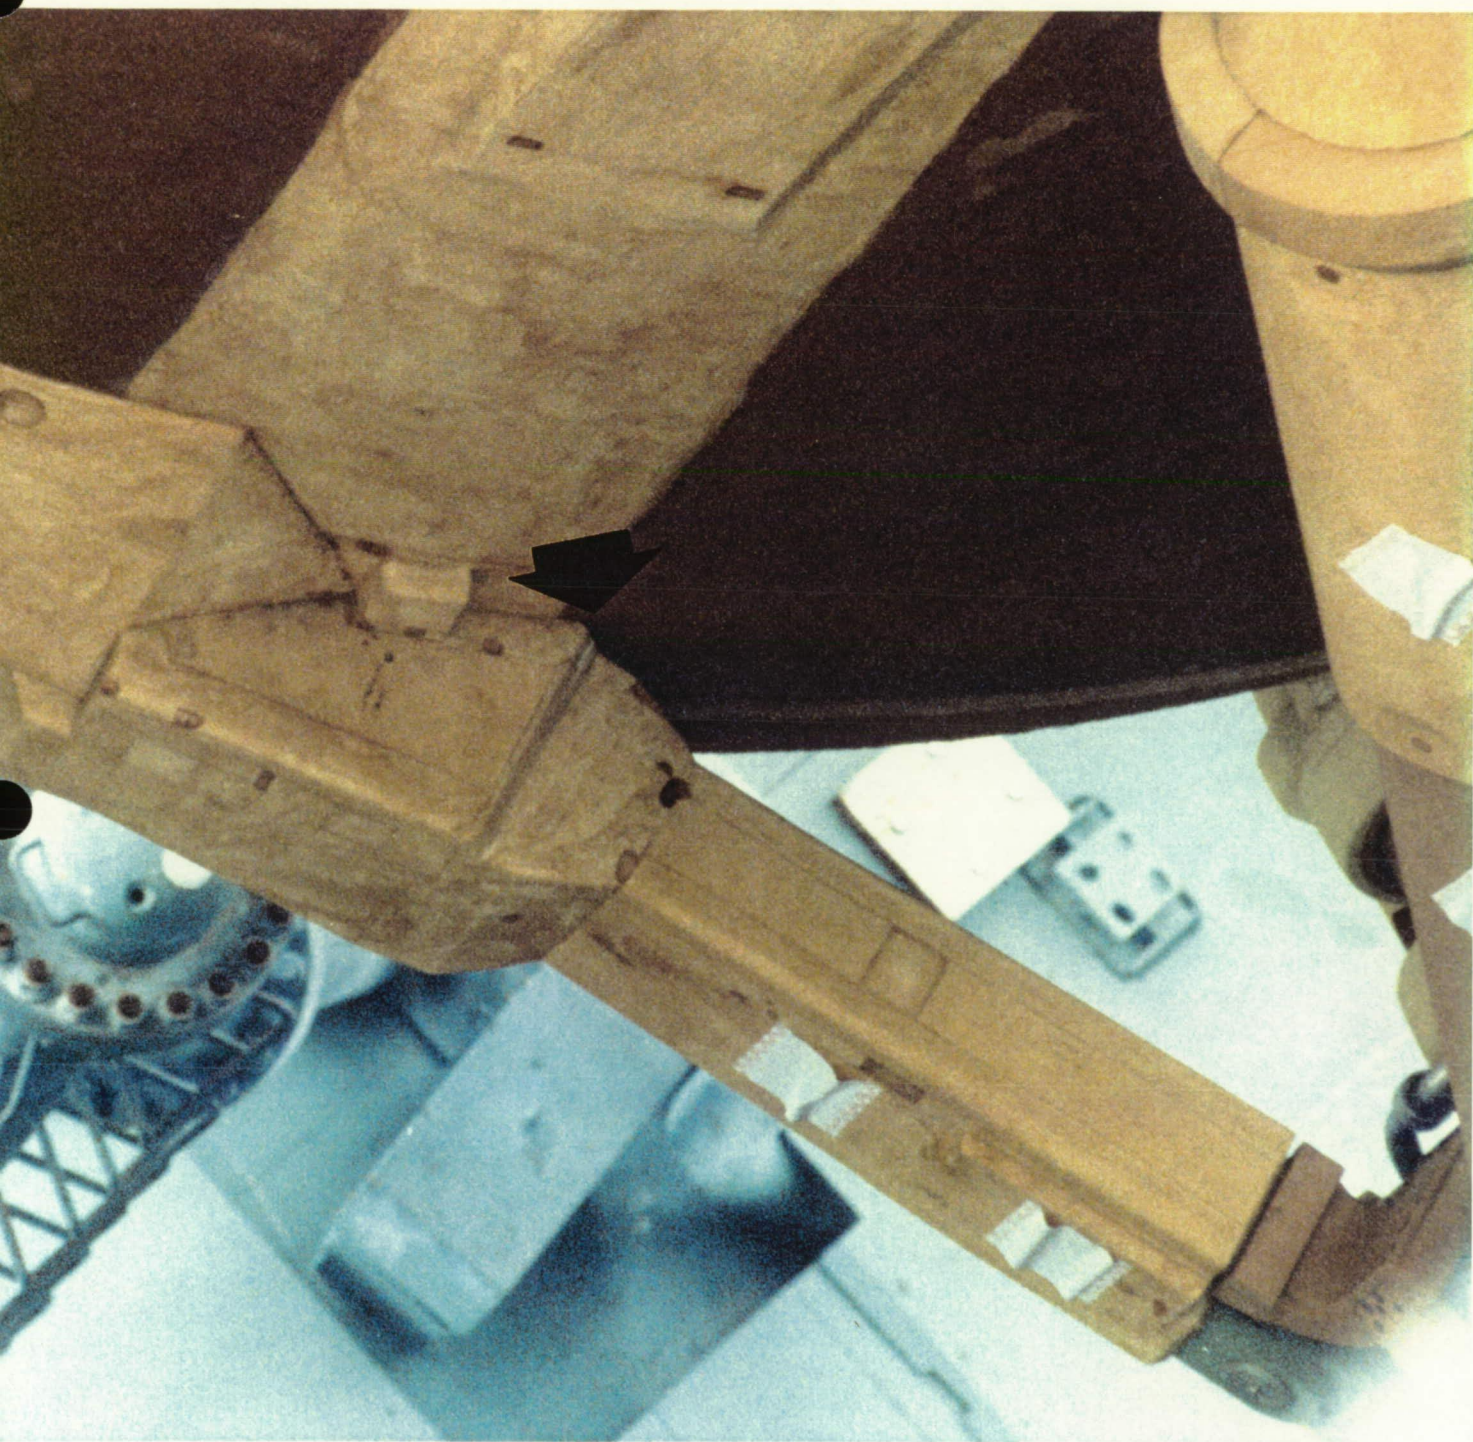
A crack 6 inches long, first detected during the FRF cryoload, was present in the -Y vertical strut cable tray forward facing surface at the tank acreage interface. A stress relief cut in the TPS to allow for structural movement had been deleted by design.

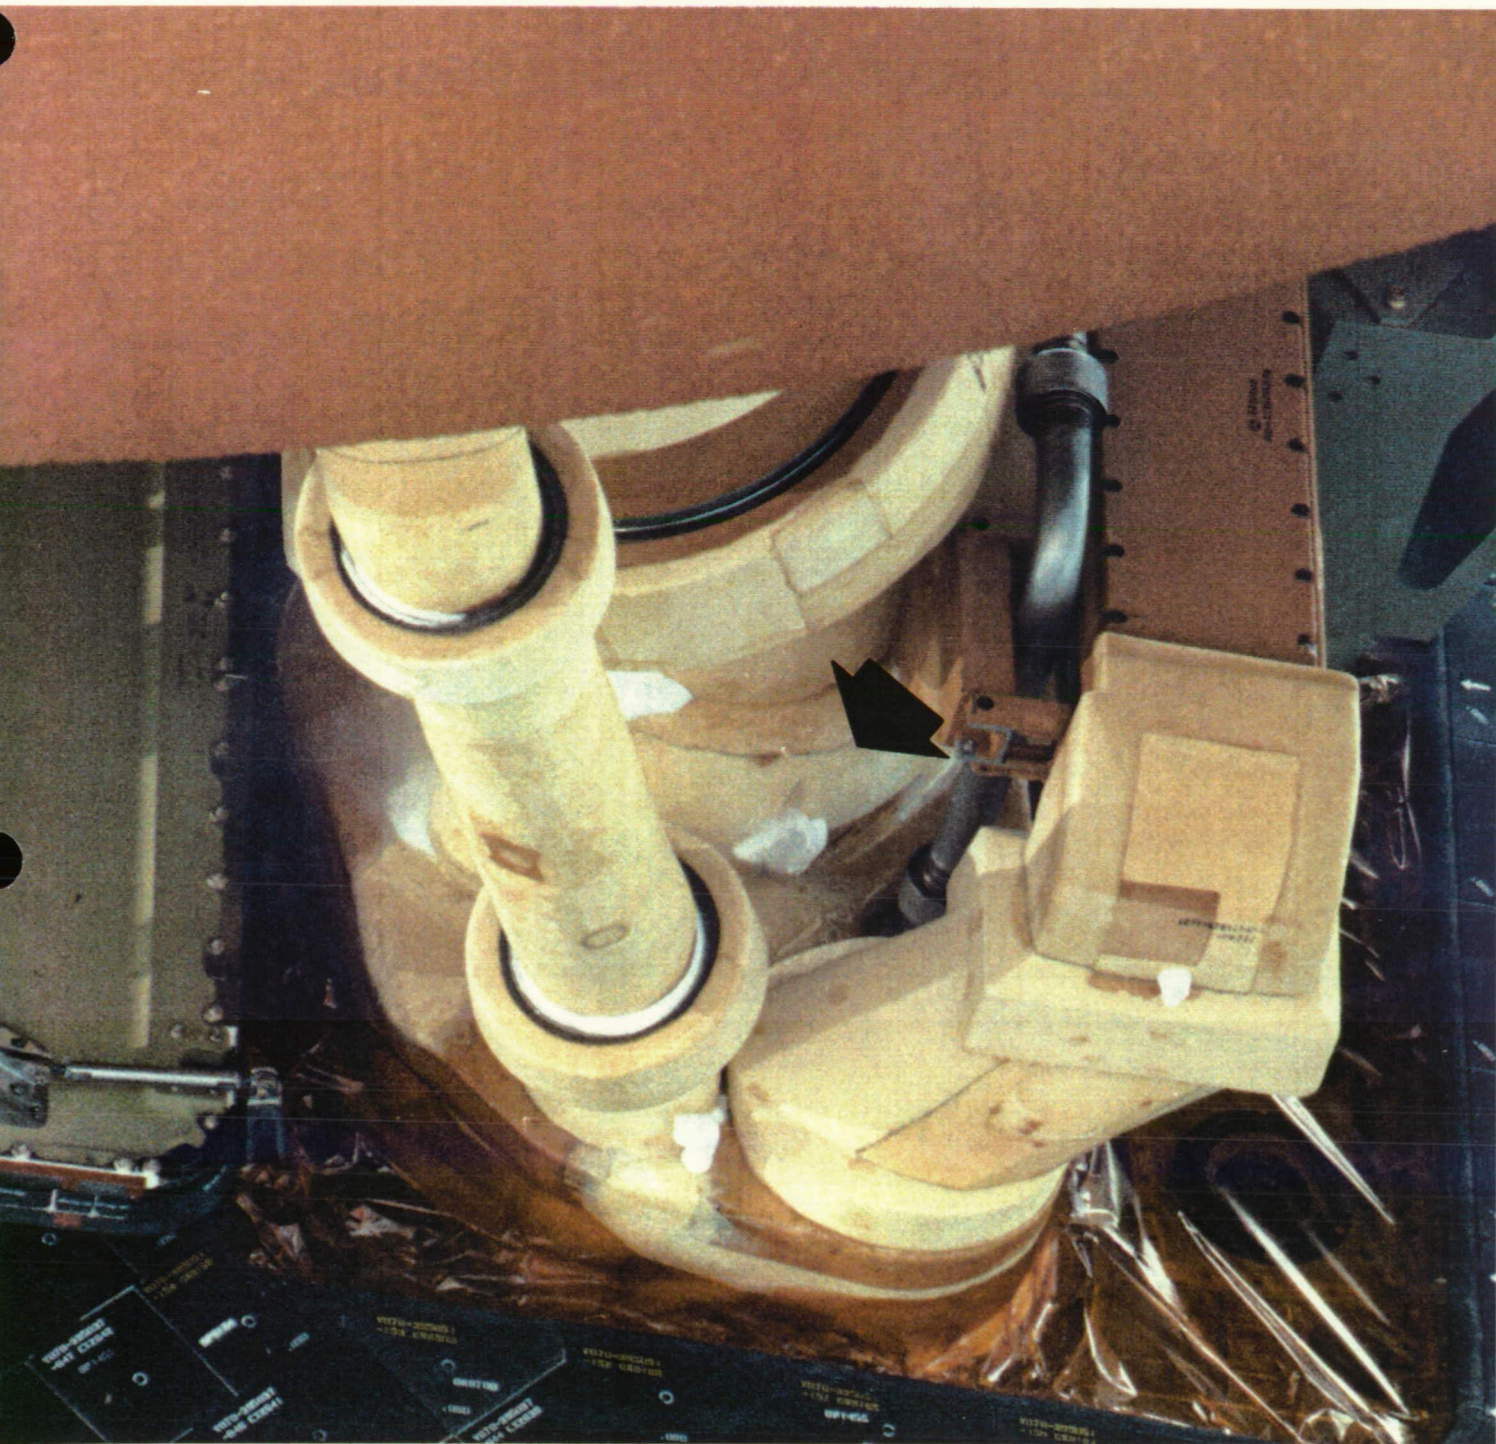
Ice/frost formations on the lower plate gap purge vent and in the LH2 recirculation line bellows were typical. The 17-inch flapper valve actuator tool access port TPS plug closeout exhibited a blowing purge gas leak and a 4-inch diameter ice formation at the forward corner. The ice formation was acceptable per NSTS-08303. MPS evaluated the venting/blowing purge gas and deemed the condition acceptable for flight.

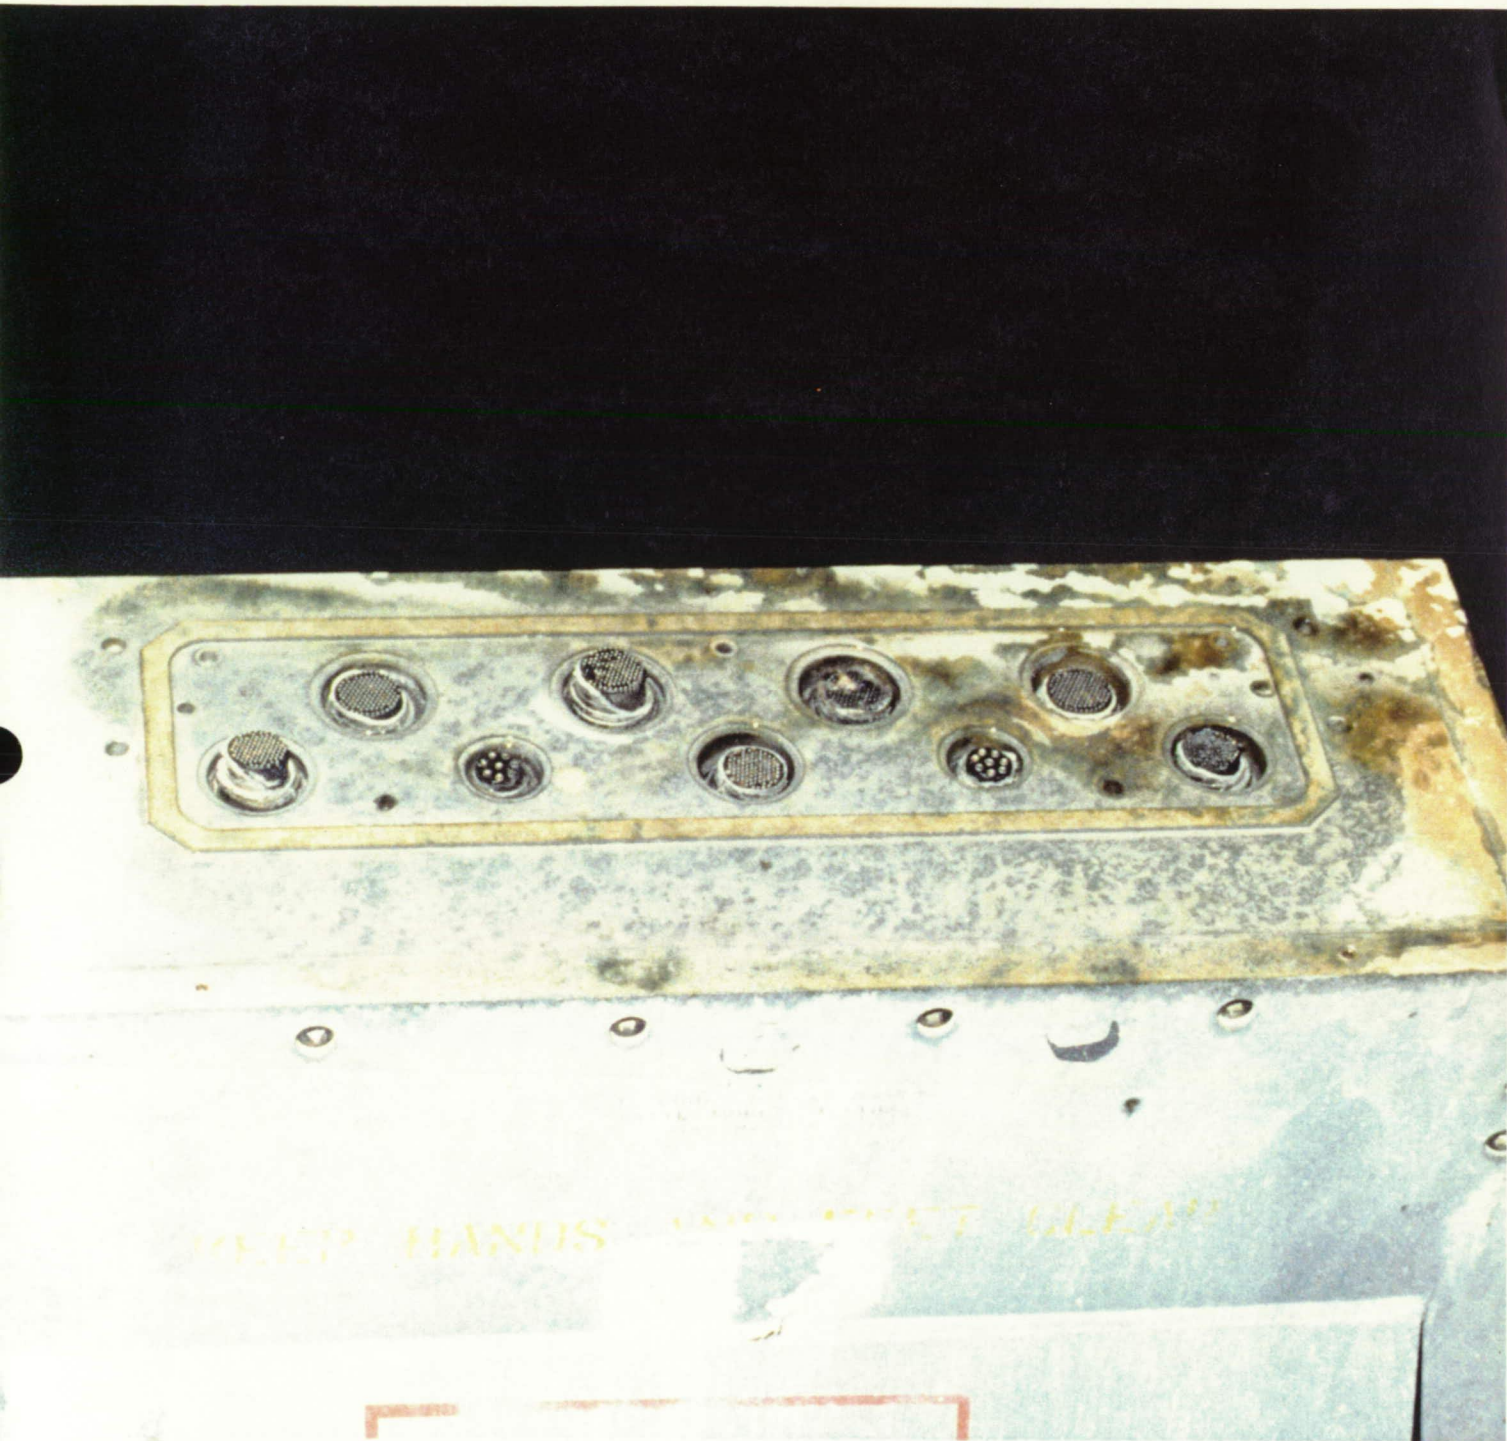
The SRB T-0 umbilicals sustained minor damage

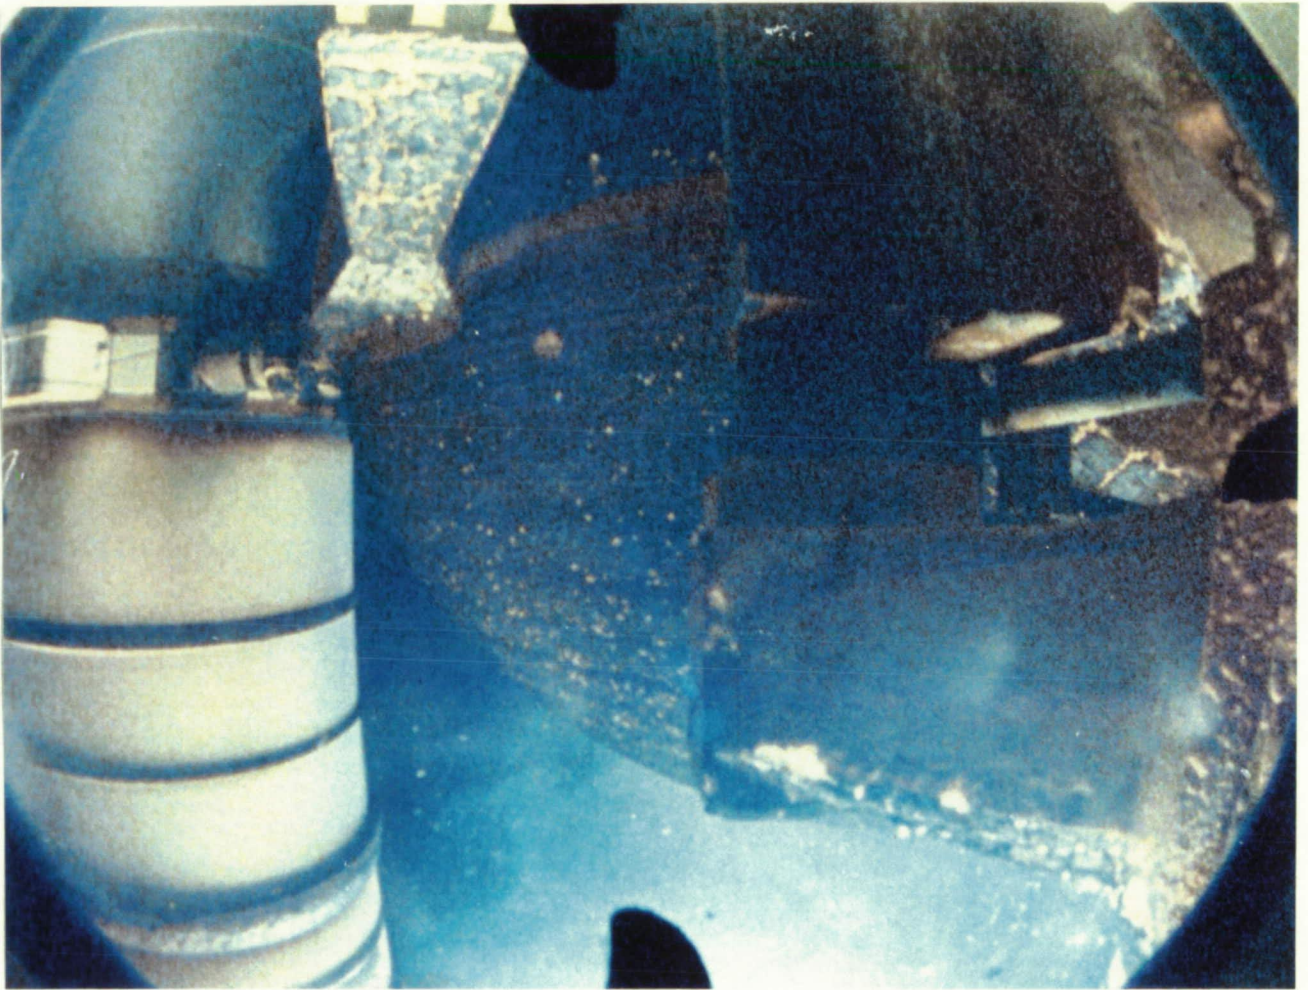
LH2 ET/ORB umbilical separation camera showed typical erosion and charring of TPS on the aft surfaces of the umbilical cable tray and -Y vertical strut. Plume recirculation and aft dome heating caused the usual charring and "popcorning" of the NCFI foam.

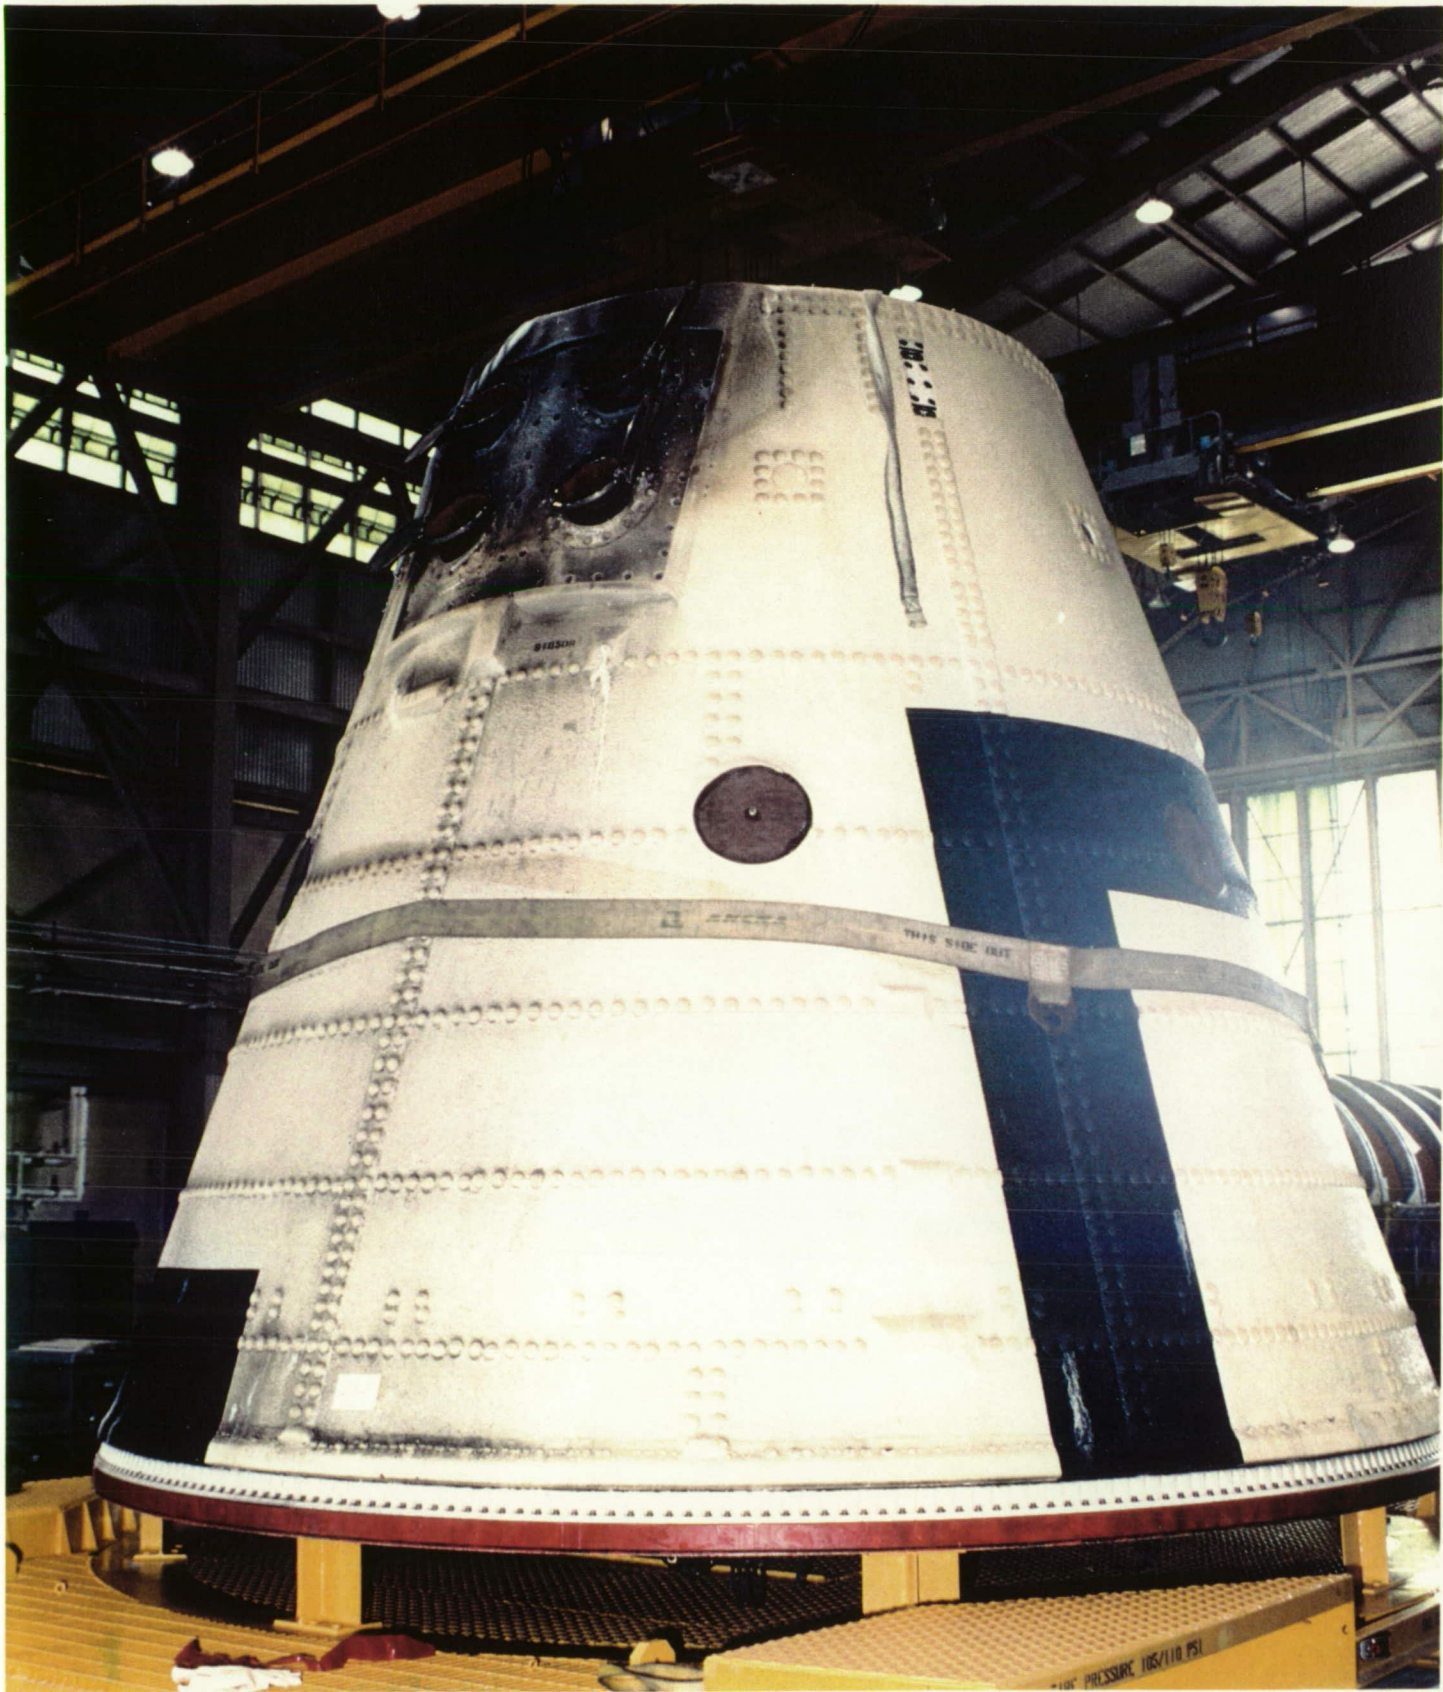
The RH frustum was missing no TPS but had 5 MSA-2 debonds over fasteners. Minor blistering of the Hypalon paint had occurred along the 395 ring. Two (right side) aero heat shield cover attach rings had been bent at the hinge by riser entanglement.
